historic structure report  
architectural data section  
phase II: exterior preservation

JEFFERSON NATIONAL EXPANSION MEMORIAL  
OLD COURTHOUSE

NATIONAL HISTORIC SITE / MISSOURI

by  
David G. Henderson

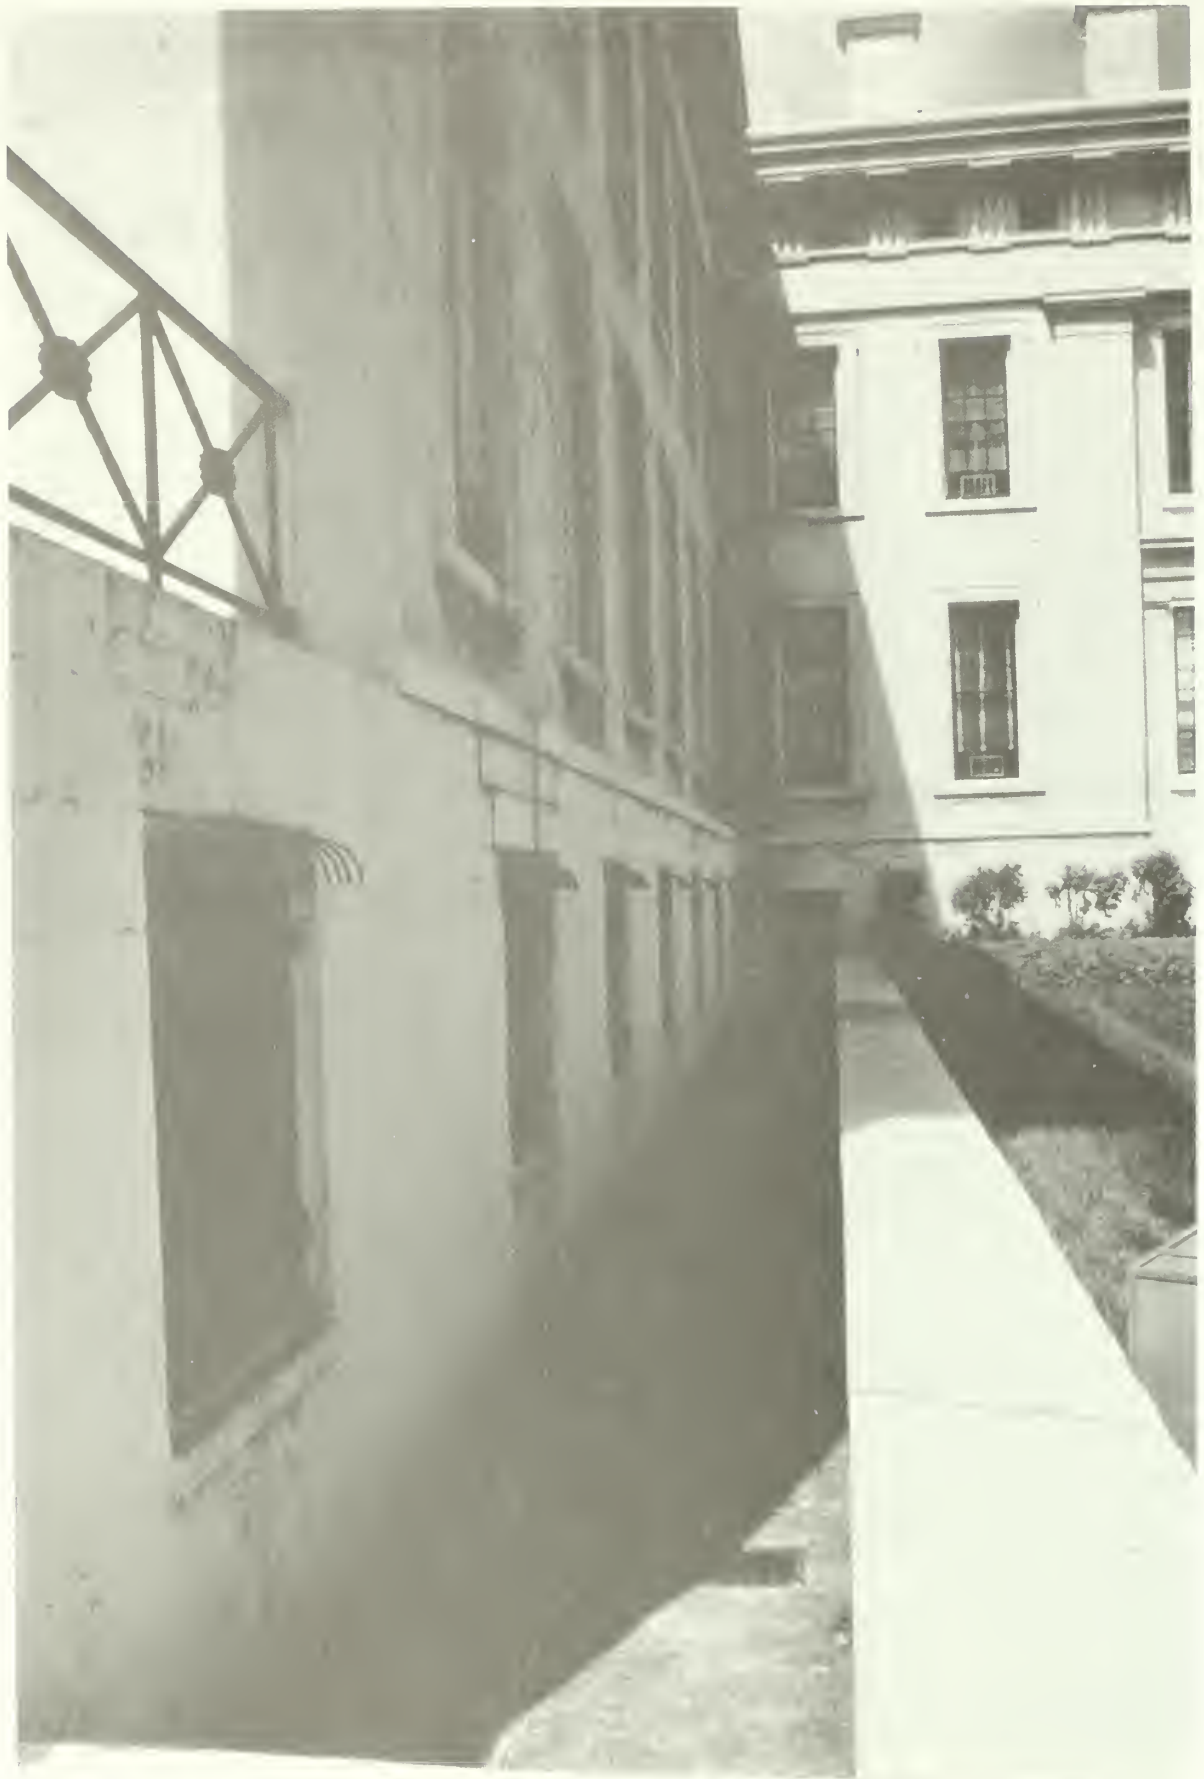
31. North areaway, east wing.

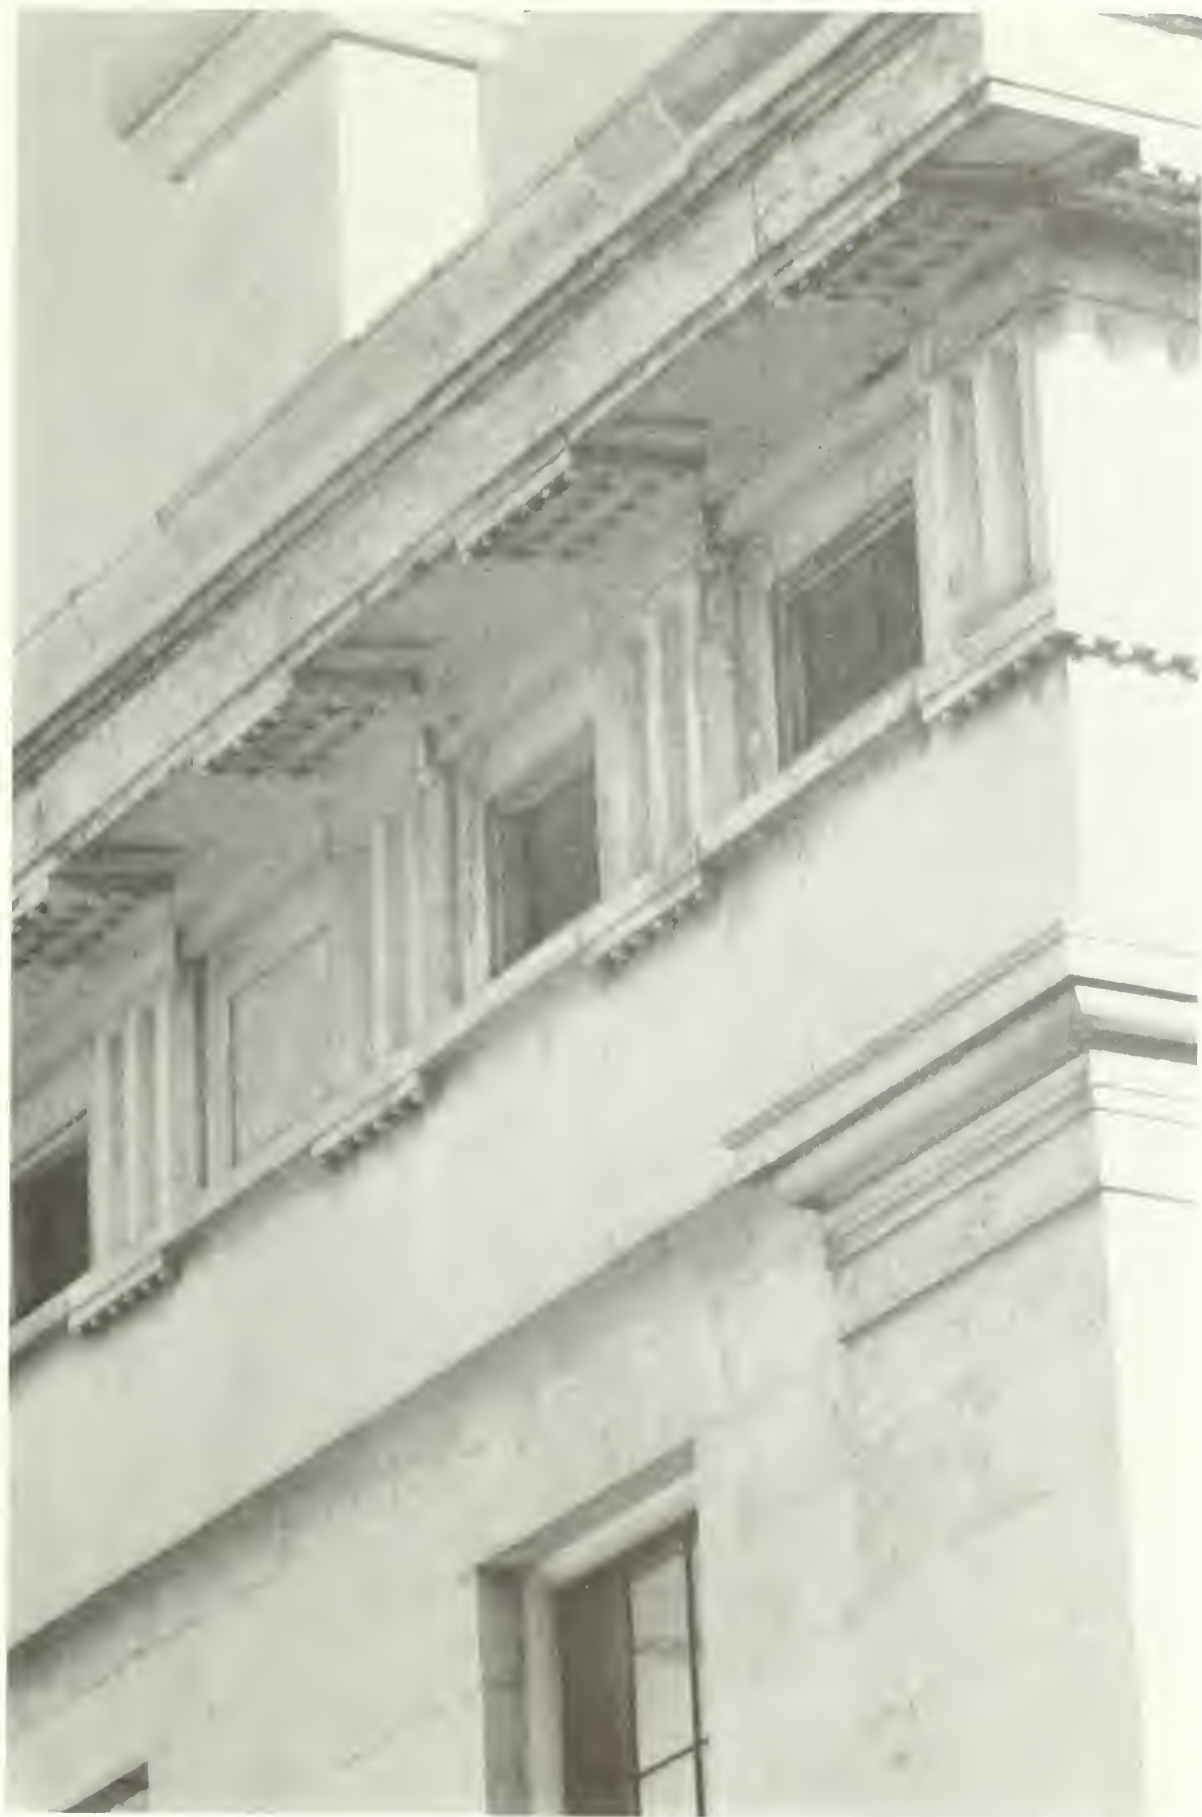
34. Typical outside corner of cornice.

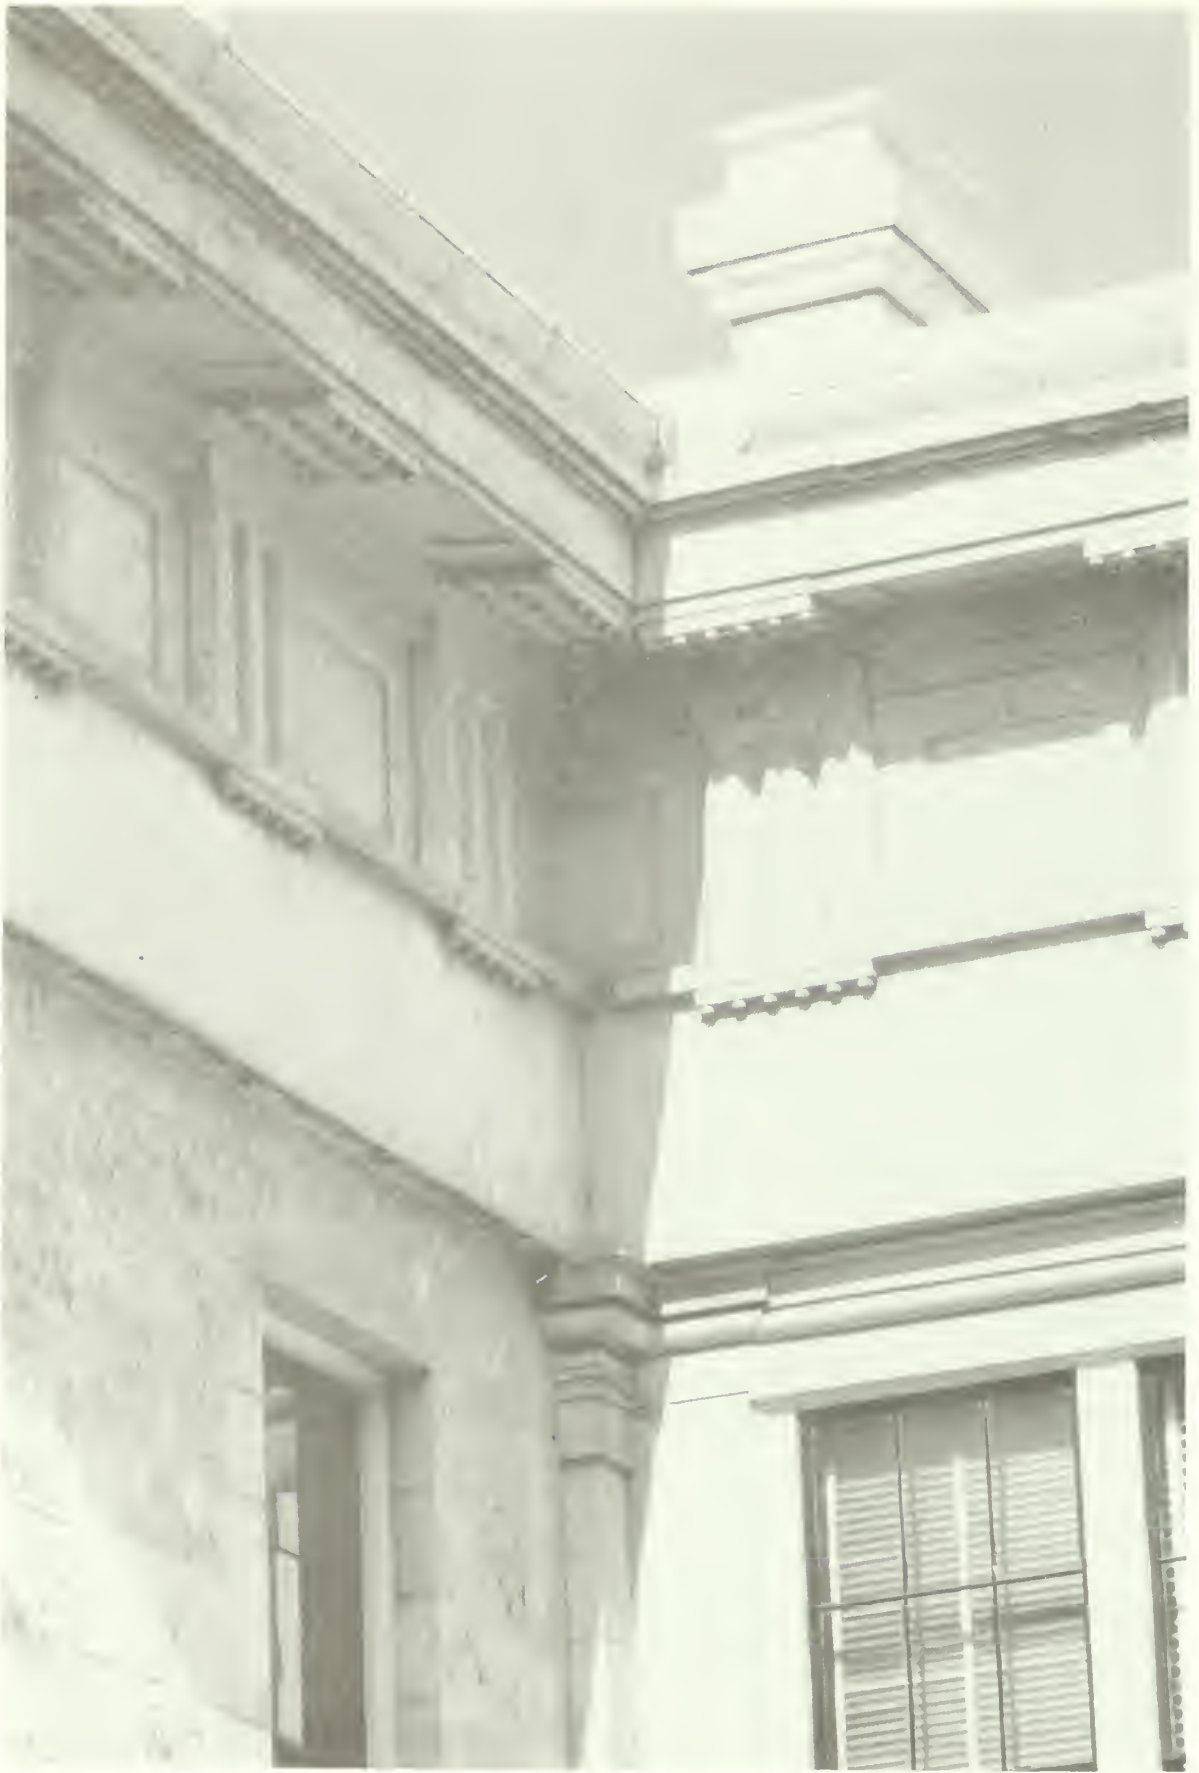
35. Typical inside corner of cornice.

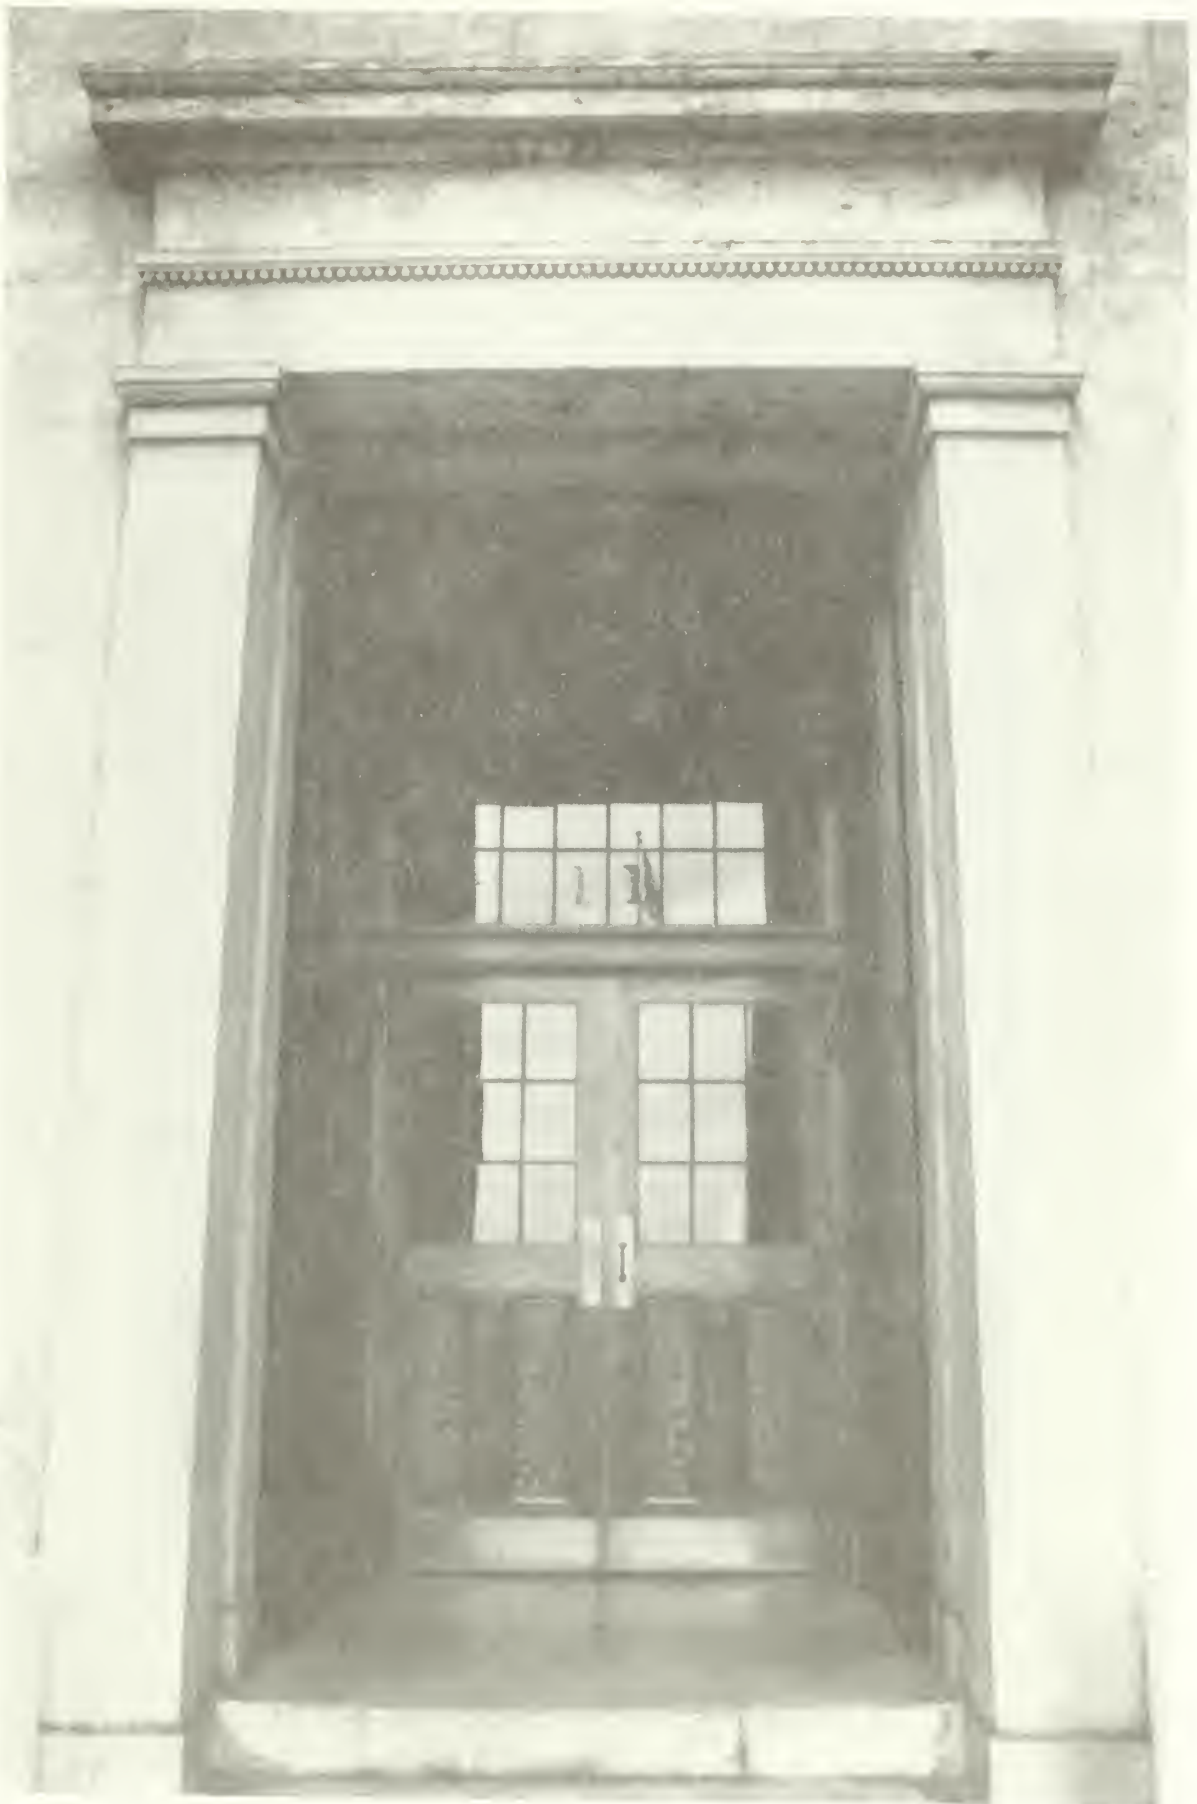
44. Doorway, east portico main entrance. All main entrances are in good condition.

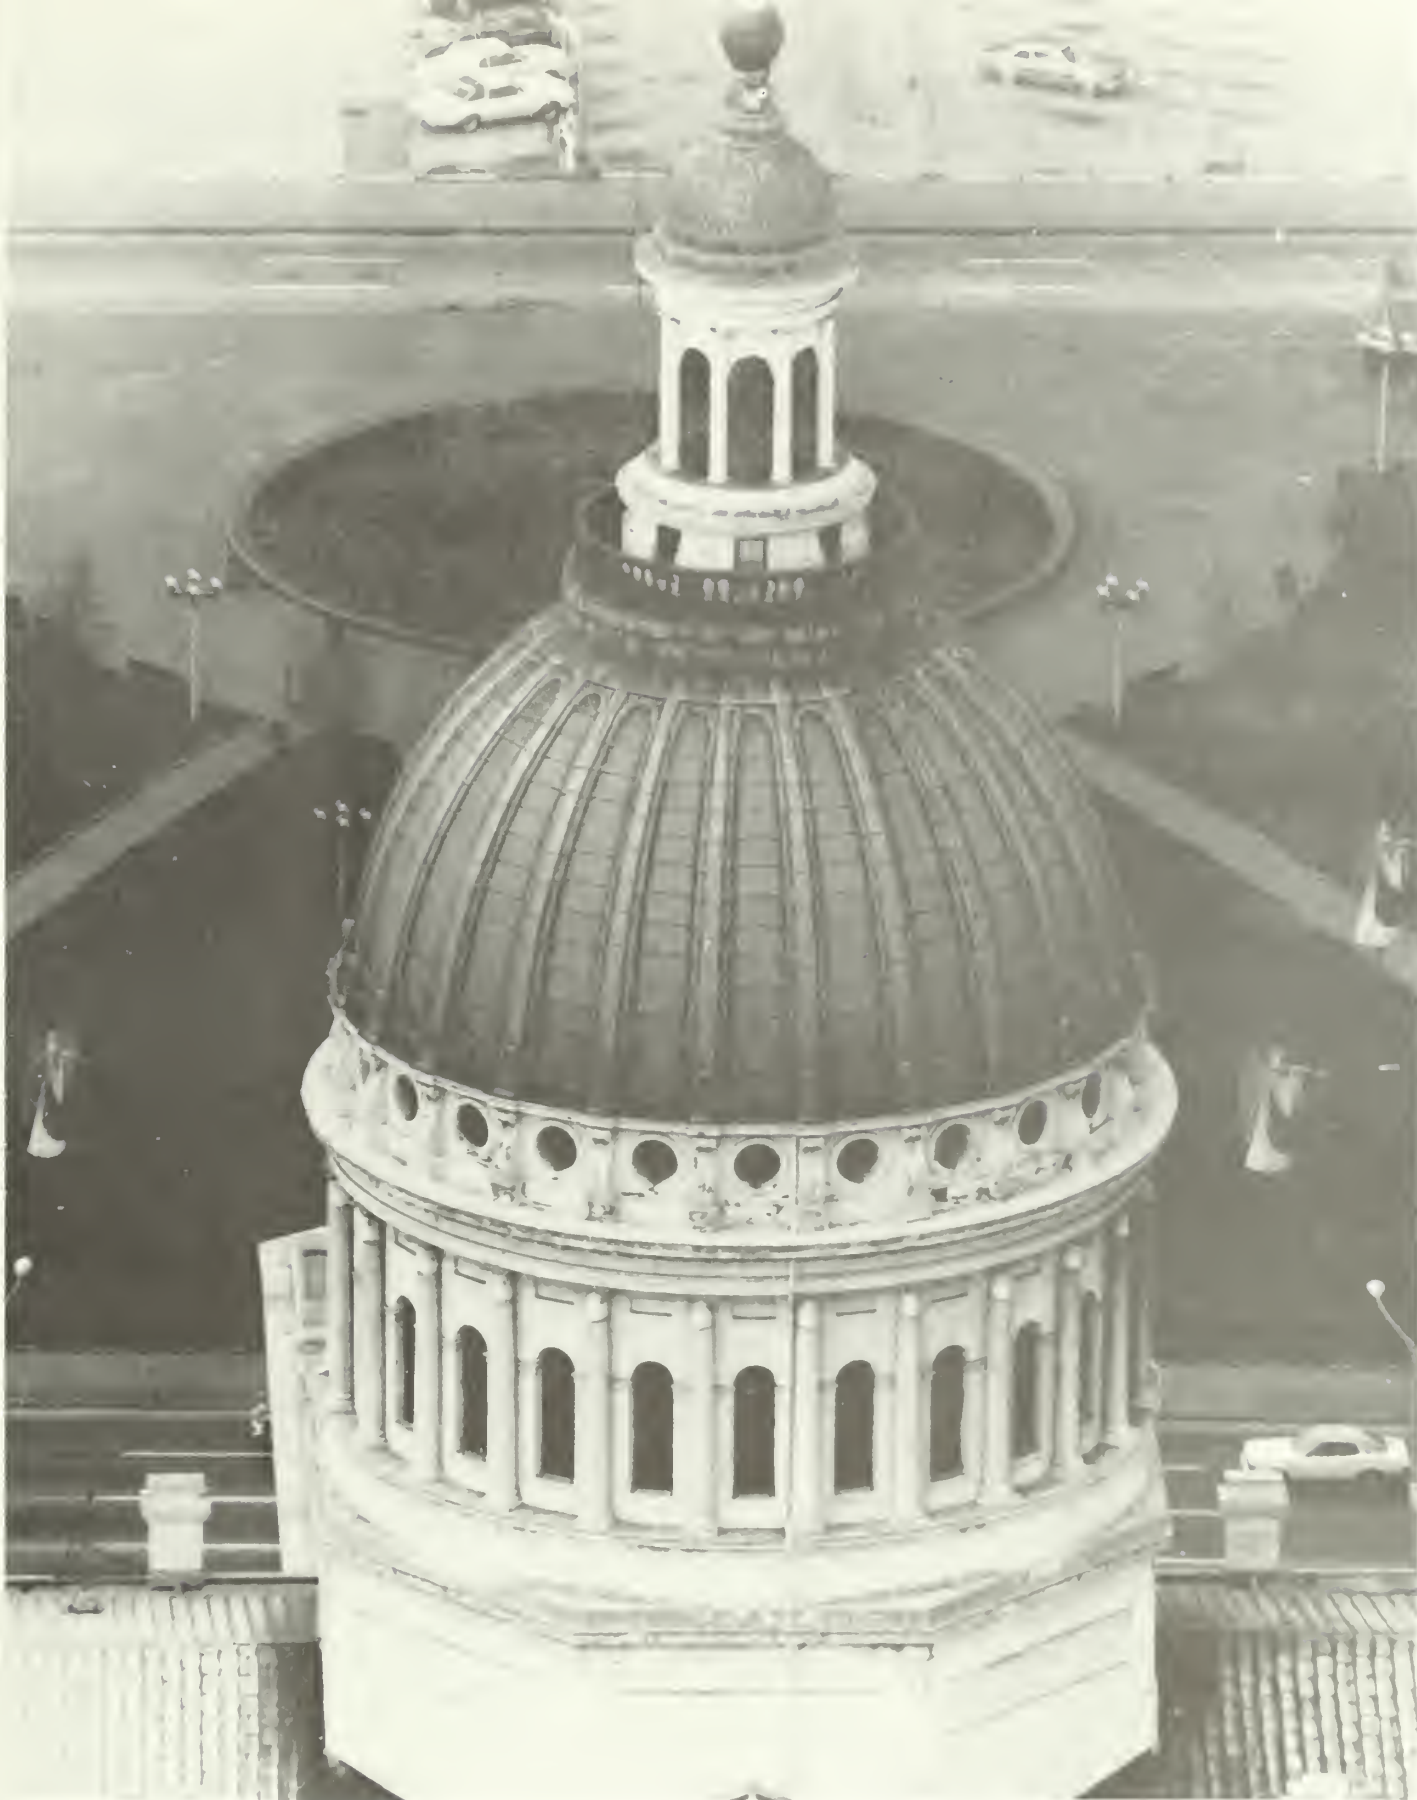
50. Looking down on tops of cornices at drums and lantern.

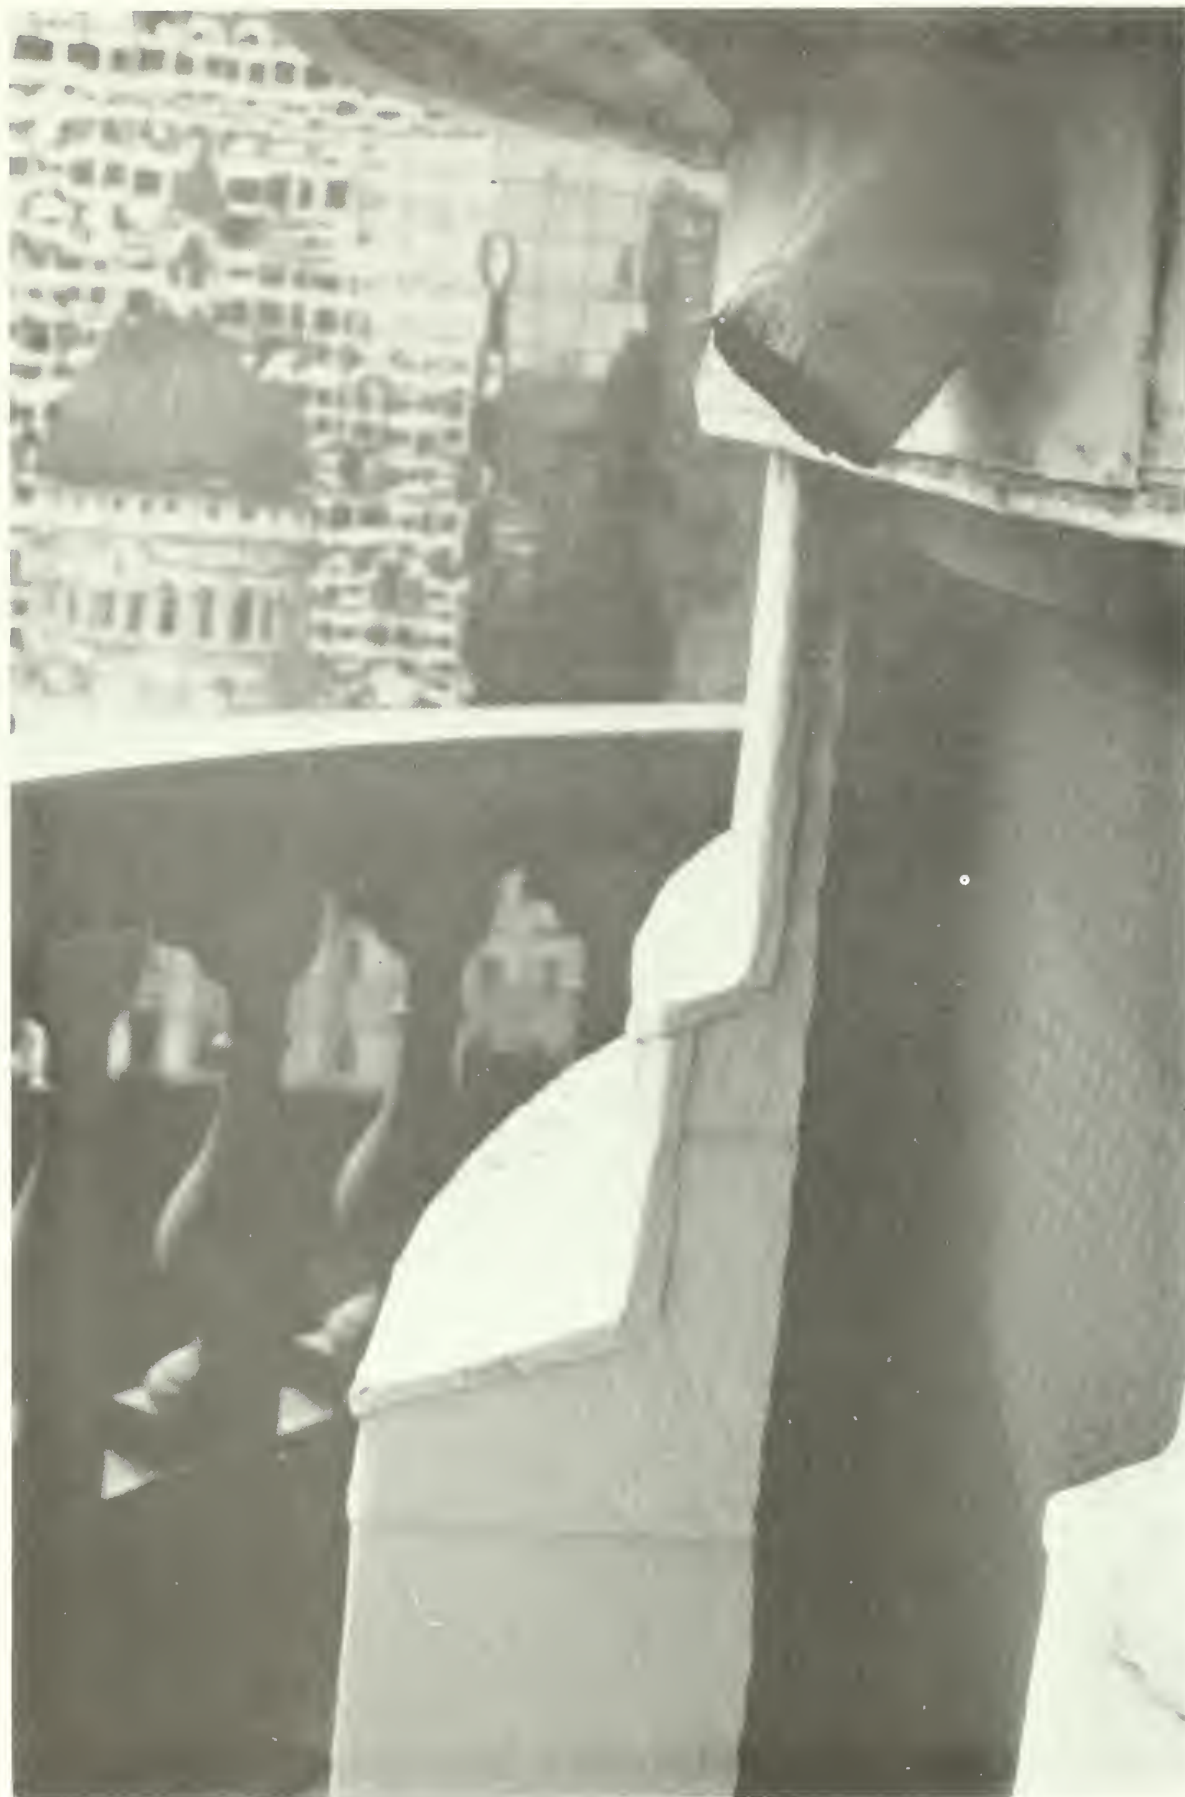
68. Upper dome and lantern. Note staining below balustrade.
